ROAD SAFETY AUDIT

West Falmouth Highway (Route 28A) between Chapoquoit Road and Old Dock Road Town of Falmouth

April 2023

Prepared By: McMahon, a Bowman company 350 Myles Standish Blvd, Suite 103 Taunton, MA 02780

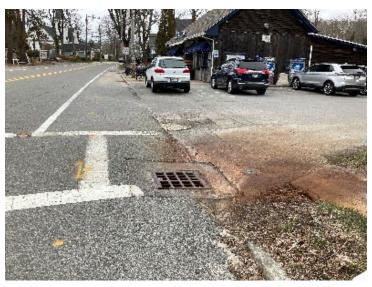
bicyclists and pedestrians traveling from the Shining Sea Bikeway to the market, ends at the market's driveway and has a storm drain in the middle of the crosswalk (Old Dock crash #6). RSA participants observed several vehicles entering the market's parking lot from the south (on Route 28A) and east (on Old Dock Road) drive over the eastern side of the crosswalk and where a landing area for the crosswalk would be located. The audit team noted that changes in the pavement and historical Google Street View images indicate that there used to be landscaping behind the crosswalk that prevented drivers from cutting over the crosswalk to enter the parking lot, but the landscaping was removed sometime between 2009 and 2011, according to historical Google Street View imagery.

Image 8: Crosswalk at the West Falmouth Market with a **Catch Basin in the Path of Travel**

- Consider relocating the crosswalk across Route 28A at Old Dock Road to an area that has greater visibility and fewer accessibility and vehicle Image 9: Crosswalk at Chapoquoit Road encroachment concerns (Old Dock crash #6)
- Bring all crosswalks to ADA compliance, including the use of high-visibility markings and the installation of compliant curb ramps
- Evaluate the feasibility of improving sidewalks on Route 28A between the West Falmouth Market and Chapoquoit Road to make them continuous and accessible
- Consider relocating utility poles where needed to have continuous sidewalks

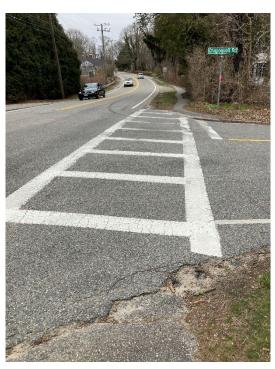
Does Not Have Accessible Curb Ramps

- Evaluate the desire lines of pedestrians and consider pedestrian infrastructure improvements where needed to better match the desire lines
- Install Rapid Rectangular Flashing Beacons (RRFBs) at crosswalks across Route 28A at Old Dock Road, the Quaker Meeting House, and the fire station'
