ROAD SAFETY AUDIT

Route 28A from Lake Drive to Palmer Avenue

Falmouth and Bourne, MA

July 2025

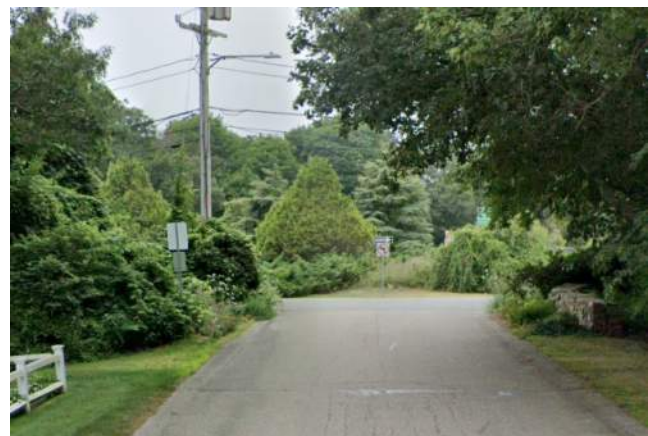
Visibility issues were also noted along curved segments of Route 28A in Falmouth, where limited sight distance and poor geometry contribute to driver uncertainty or unexpected conditions ahead. In some cases, such as near Althea Road, motorists were reported to not stop properly for school buses, suggesting a lack of awareness or insufficient warning signage.

Image 1: View from Rockledge Drive Looking West towards the Silver Beach Rotary with Limited Visibility (Google)

- Consider removing/mitigating obstructions to sight distance throughout the corridor.
- Consider implementing appropriate countermeasures to address sight distance deficiencies, such as clearing vegetation, relocating obstructions, or adjusting roadway features to improve sight lines.

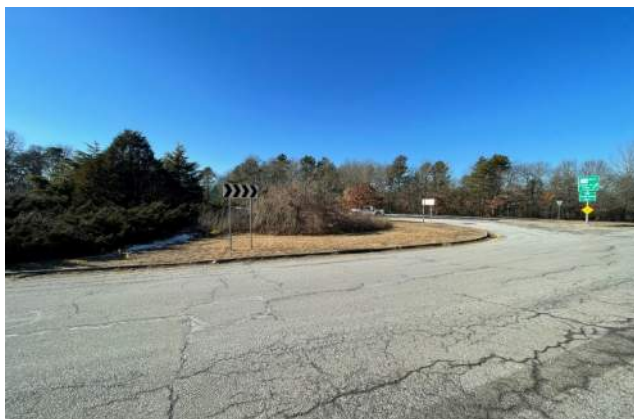
Signage deficiencies along the Route 28A corridor were another critical issue raised during the discussion. Participants emphasized issues with proper placement, particularly for stop signs, no passing zone signs (see Safety Issue #3), and speed limit signs. Corridor-wide concerns included a lack of enhanced signage at key locations. Although black and white chevron R6-4 signs were installed at the Silver Beach Rotary during 2024 as part of a signing work order, participants still noted visibility and guidance issues at the rotary entrance. The audit team also noted that this location lacks intersection warning signage to alert drivers of the approaching traffic circle. Additionally, the audit team noted that a lack of curve warning signage along the corridor may contribute to driver unawareness and safety in areas with limited sight lines. Crash data supports this concern, with ten roadway departure crashes (Crashes #1, 20, 30, 39, 40, 41, 54, 62, 63, and 68) occurring at or near curves where drivers lost control and veered off the roadway. Many of these crashes involved collisions with utility poles, trees, embankments, or other fixed objects, often under poor weather or high-speed conditions.

Image 2: View from Rockledge Drive Looking Northwest at the Silver Beach Rotary with Limited Signage

- Consider installing flashing LED STOP signs and advanced warning signage, where appropriate, to provide increased conspicuity of signage to drivers.
- At the Silver Beach Rotary, consider replacing existing black and white chevron R6-4 signs with new One-Way (R6-1 or R6-2) signs and reflectors to improve driver awareness, and consider installing additional roundabout pavement markings (including yield lines). Ensure that all new and existing signage and markings meet current standards, particularly for nighttime and low-light conditions.

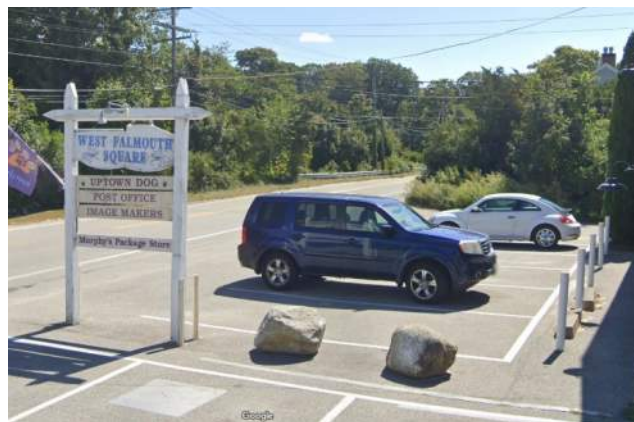
Image 3: West Falmouth Square (Post Office): Vegetation Obstructing Sight Lines for Vehicles Exiting Parking Lot (Google)

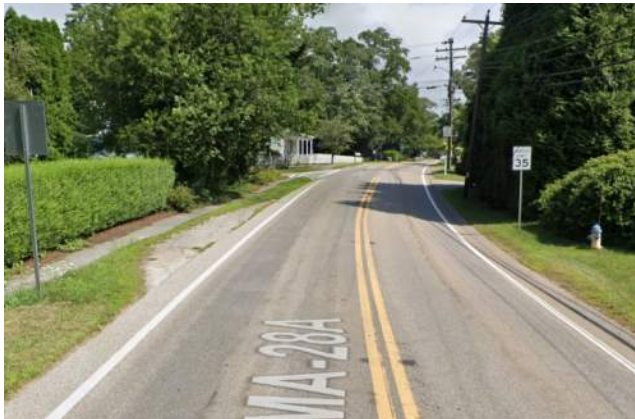
In particular, the segment near West Falmouth Square was identified as a concern. Participants noted that drivers entering this village area may not reduce their speed appropriately due to unclear transitions and lack of visual cues. The current location of the 35-mph speed limit signs was viewed as misaligned with the actual village context, contributing to inconsistent driver behavior and reduced compliance. Wide lanes, long uninterrupted segments, and a lack of gateway features may further contribute to driver overconfidence, reduced speed compliance and speed inconsistency.

Image 5: View from Route 28A Looking North towards Chapoquoit Road with 35-mph sign on the near right (Google)

- Identify missing, damaged, or poorly placed speed limit signs and consider replacing or installing new speed limit signs where needed.
- Consider evaluating the potential use of gateway treatments at key transition points to alert drivers entering reduced speed zones.

- Ensure all speed limit signs are properly placed, visible, and retroreflective to maximize effectiveness, particularly for nighttime and low-light conditions.

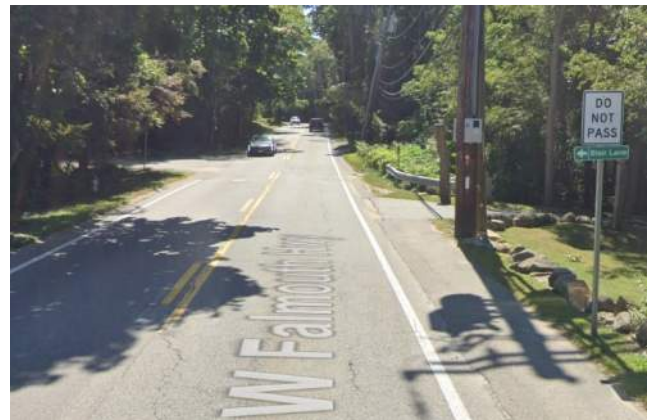
- West Falmouth Square and Blair Lane: The participants noted the presence of a passing zone in this area and suggested that this passing zone may not be necessary, posing safety concerns given the surrounding roadway context and turning movements.

Image 7: View from Route 28A Looking South towards Blair Lane with end of passing zone (Google)

- Evaluate the need for passing zones throughout the entire Route 28A corridor, considering factors such as speed limit, sight distance, traffic patterns, and road user needs.
 - In the West Falmouth Square area, specifically review the passing zone near Blair Lane and consider removing it to enhance safety.
- Consider reviewing all no passing zone signage along the corridor and relocate or replace as needed to ensure that signage is visible, and placed accordingly to clearly communicate the restrictions to drivers.

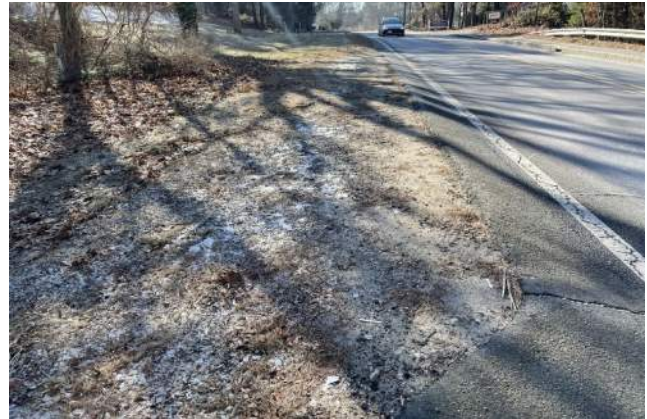
Image 8: Desire lines for pedestrian accommodation on Route 28A North

Participants noted that pedestrian desire lines reflect where people are walking despite the absence of safe or designated paths. They also noted that both year-round and seasonal pedestrian movements differ significantly due to the substantial population increase during summer months (from approximately 35,000–40,000 to 120,000).

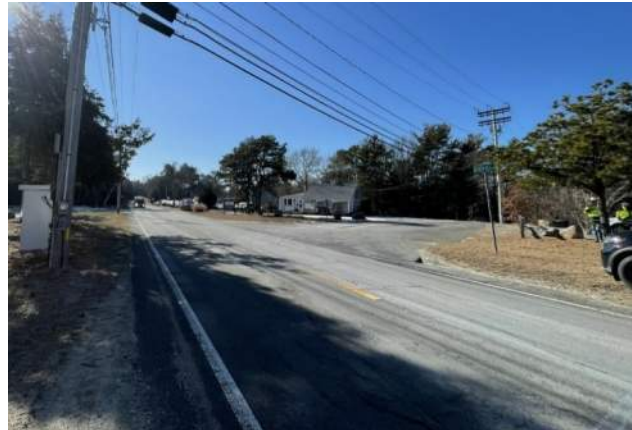
Image 9: Looking South on Route 28A near Scraggy Neck Road.

- Consider evaluating the condition of the existing sidewalks and determine whether they can be repaired/restored to a safe condition or whether they require significant upgrades.

- Consider developing a proactive vegetation and obstruction management plan that includes regular assessment and maintenance and repair of sidewalks to ensure they provide a safe walking surface.

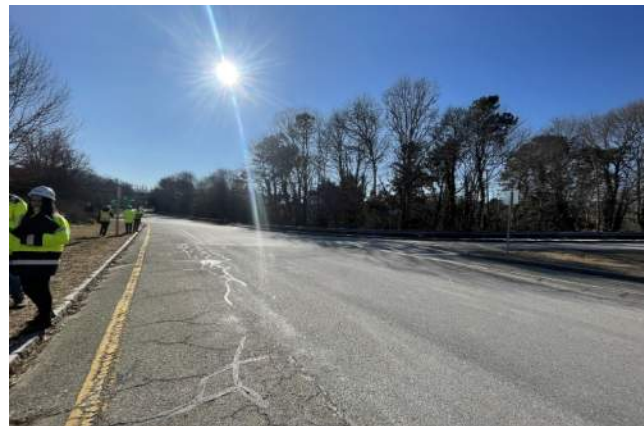
General concerns were noted regarding intersection design and geometry throughout the corridor. Participants emphasized that wide turning radii and high-speed approaches at some intersections encourage drivers to maintain high speeds even while turning, creating significant safety risks.

Image 10: Silver Beach Rotary looking at the North Falmouth Hwy South rotary exit with guardrail on the right side.

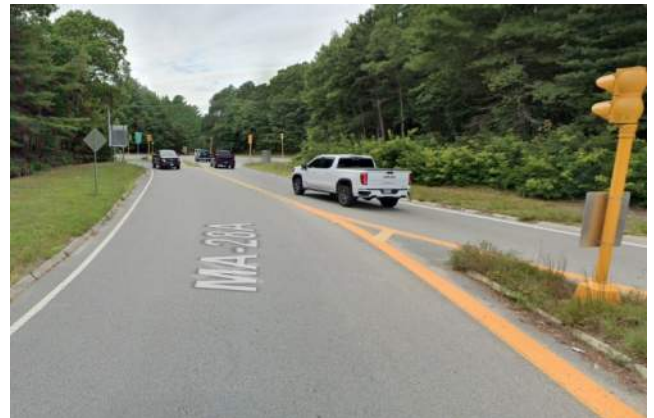
Image 11: View from Route 28A Onramp to Route 28 SB Looking West at the Lake Drive / Roberta Avenue / Sandwich Road Intersection with no median barrier (Google)
