WEST FALMOUTH HARBOR RESTORATION FEASIBILITY STUDY

Final Report

CAPE COD CONSERVATION DISTRICT

**MASSACHUSETTS DEPARTMENT OF ENVIRONMENTAL
PROTECTION**

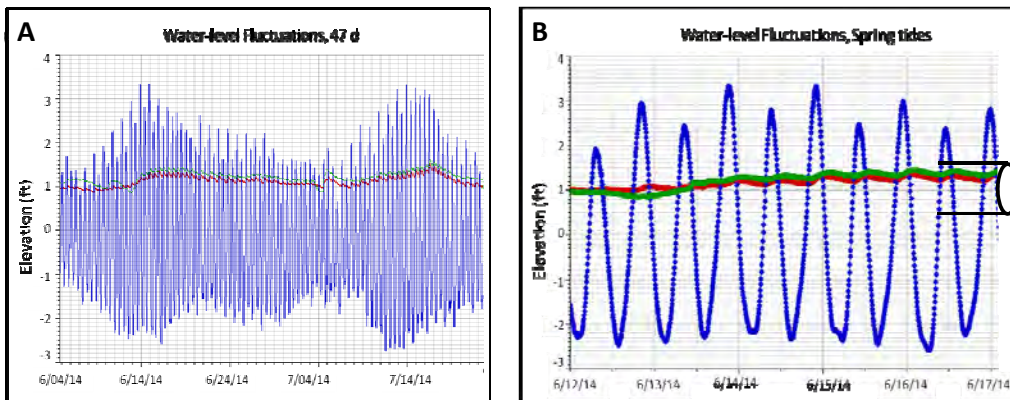
Figure 3.4. Water level fluctuations in West Falmouth Harbor (blue) and Little Neck Bay (red): (A) fluctuations over the 47-day period of record, (B) fluctuations over 5 days during Spring tides. Chapaquoit Road culvert position and size shown on right.

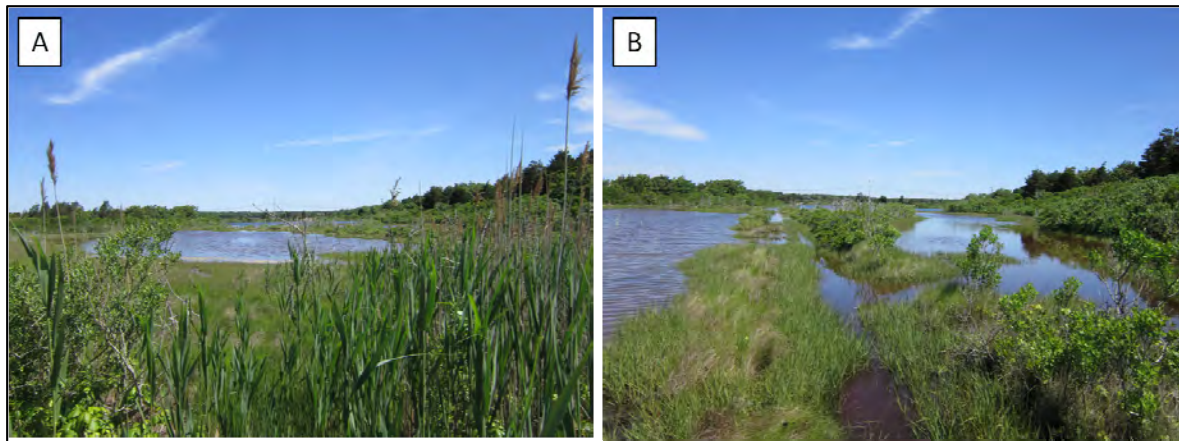
Figure 3.5. Views of Little Neck Bay: (A) looking north from Little Neck Bars Road with a *Phragmites* fringe in foreground, (B) mosquito ditch with a shrub line growing on a spoil berm on the right side of the ditch. Snags are seen in the distance, center of picture.

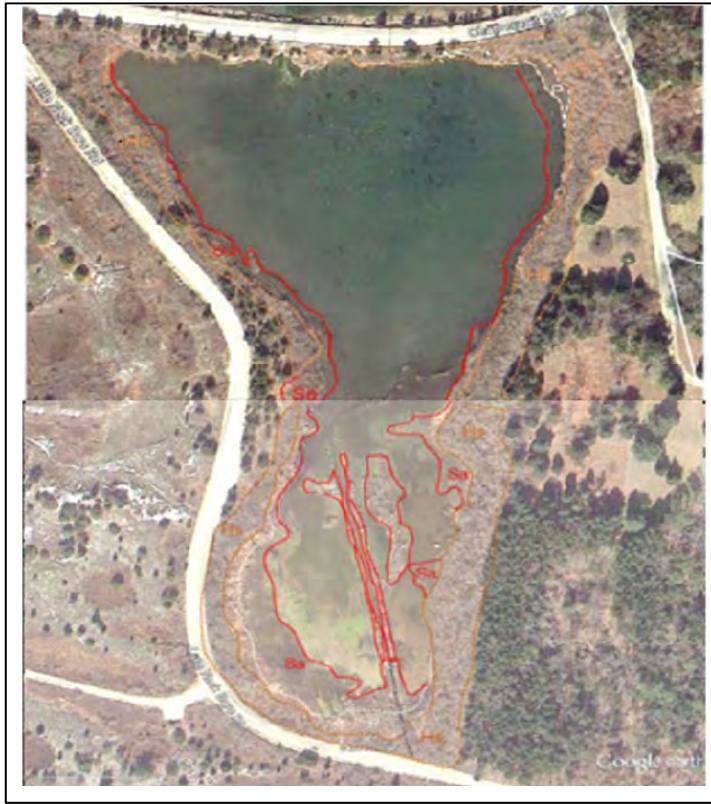
Figure 3.6. Spatial distribution of marsh cover-types in Little Neck Bay.
Abbreviations: P= *Phragmites*, Sa= *Spartina alterniflora*, Sp= *Spartina patens*, Hs= high shrub, Ls= low shrub, M= mud flat, Pa= salt panne.

3.1.5 Spatial distribution of marsh cover-types. Little Neck Bay supports seven distinctive marsh cover types: *Spartina alterniflora* and *S. patens* marshes, fringing *Phragmites* marsh, low shrub, high shrub, mud flat, and salt panne. The estimated spatial distribution among these types was manually drawn in the field on aerial photos and transferred digitally to maps (Figure 3.6). This spatial distribution of cover types on these maps provides a baseline to compare changes in cover types after culvert enlargements have been completed, bearing in mind that it might take several years for vegetation changes to fully take place after tidal exchange is improved.

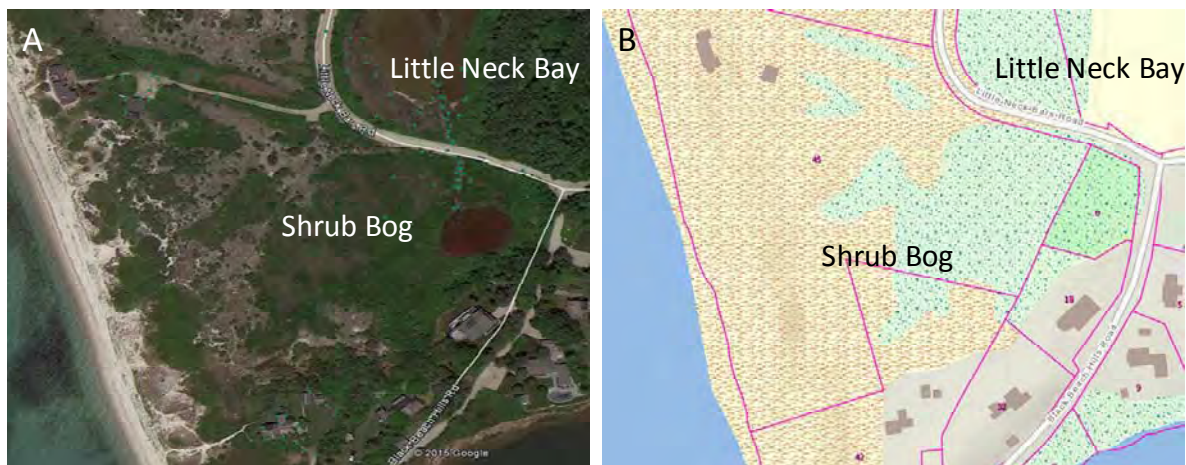
Figure 3.7. Location of Shrub Bog relative to Little Neck Bay: (A) turquoise dots are locations of RTK points collected in and near Shrub Bog, (B) parcel map (Mass GIS) of abutting properties.

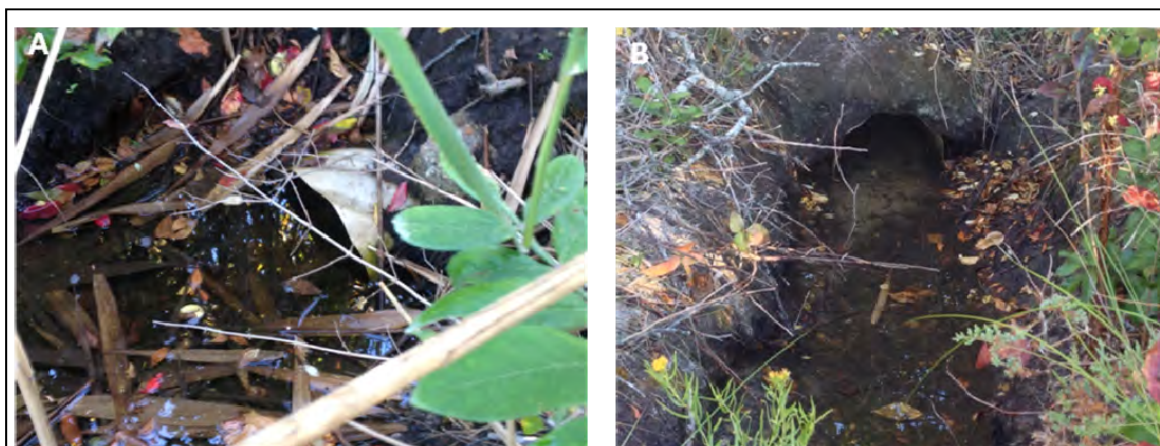
Figure 3.8. Culvert under Little Neck Bars Road, connecting Shrub Bog to Little Neck Bay: (A) culvert opening on downstream, Little Neck Bay side, (B) culvert opening on upstream, Shrub Bog side.

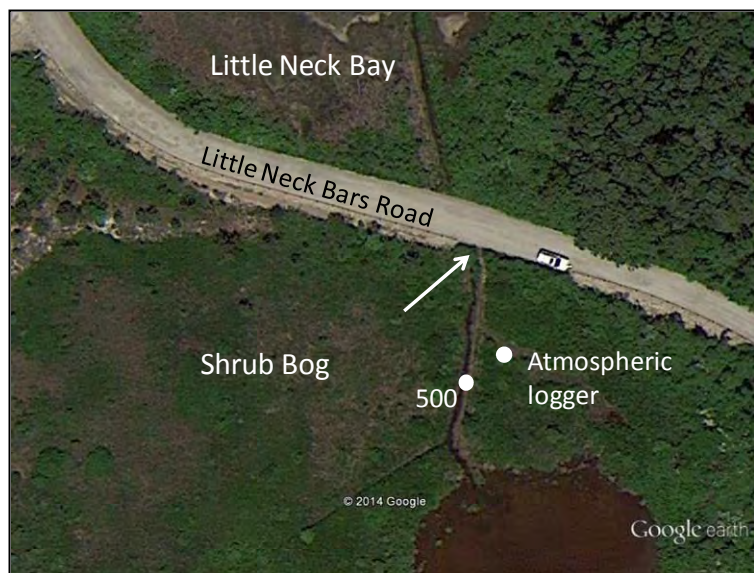
Figure 3.9. Location of the data logger in Shrub Bog (#500), upstream of the culvert to connecting shrub Bog to Little Neck Bay. The arrow points to the location of the culvert on the upstream (south side) of the restriction.

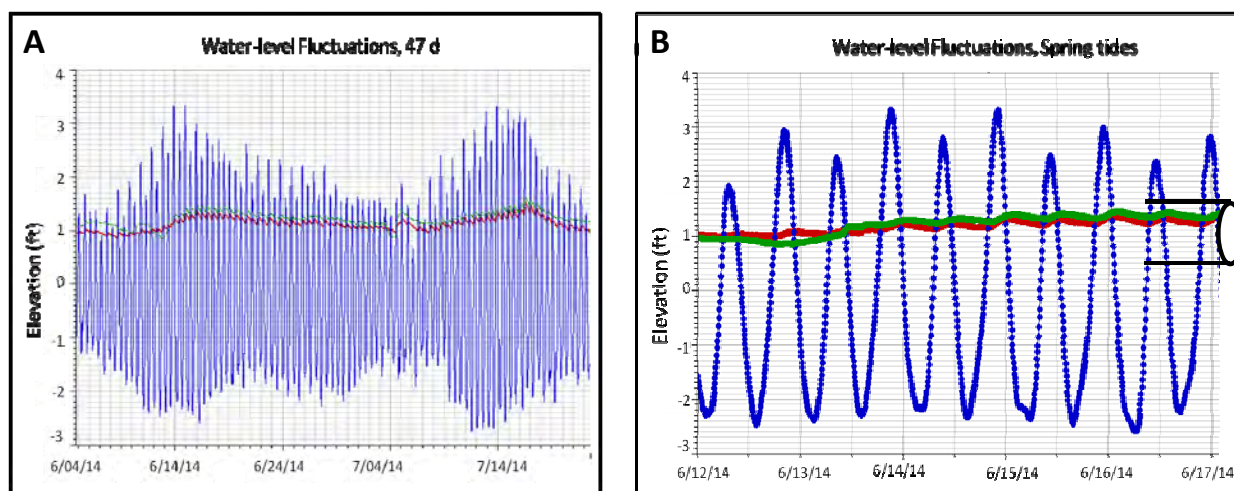
Figure 3.10. Water level fluctuations in West Falmouth Harbor (blue), Little Neck Bay (red), and Shrub Bog (green): (A) fluctuations over the 47-day period of record, (B) fluctuations over 5 days during Spring tides. Chapaquoit Road culvert position and size shown on right.

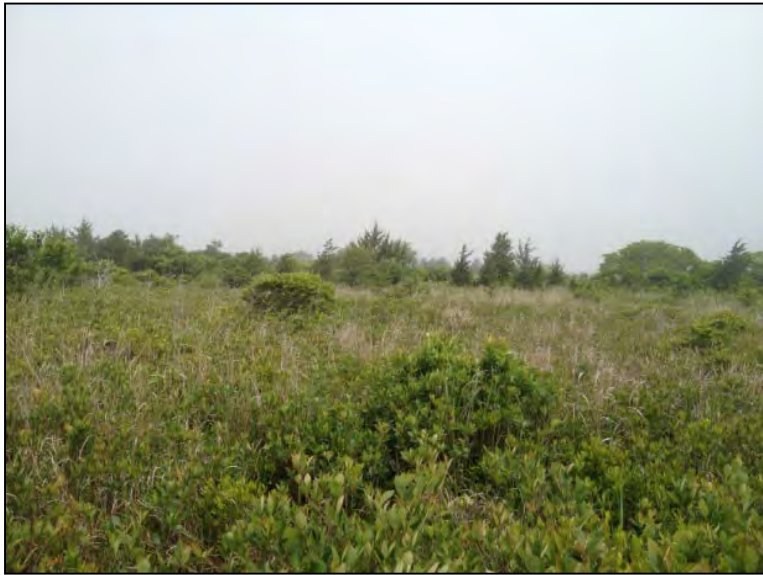
Figure 3.11. View of Shrub Bog vegetation, looking northwest.

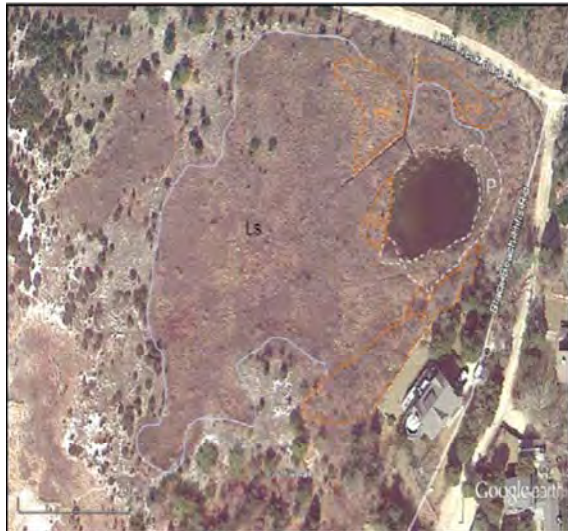
Figure 3.12. Spatial distribution of marsh cover-types in Shrub Bog. Abbreviations: P= *Phragmites*, Hs= high shrub, Ls= low shrub.

3.2.4 Spatial distribution of marsh cover-types. Shrub Bog supports three distinctive cover types: *Phragmites* fringing marsh, low shrub, and high shrub. The estimated spatial distribution among these types was manually drawn in the field on aerial photos and transferred digitally to maps (Figure 3.12). This spatial distribution of cover types on these maps provides a baseline to compare changes in cover types after culvert enlargements have been completed, bearing in mind that it might take several years for vegetation changes to fully take place after tidal exchange is improved.

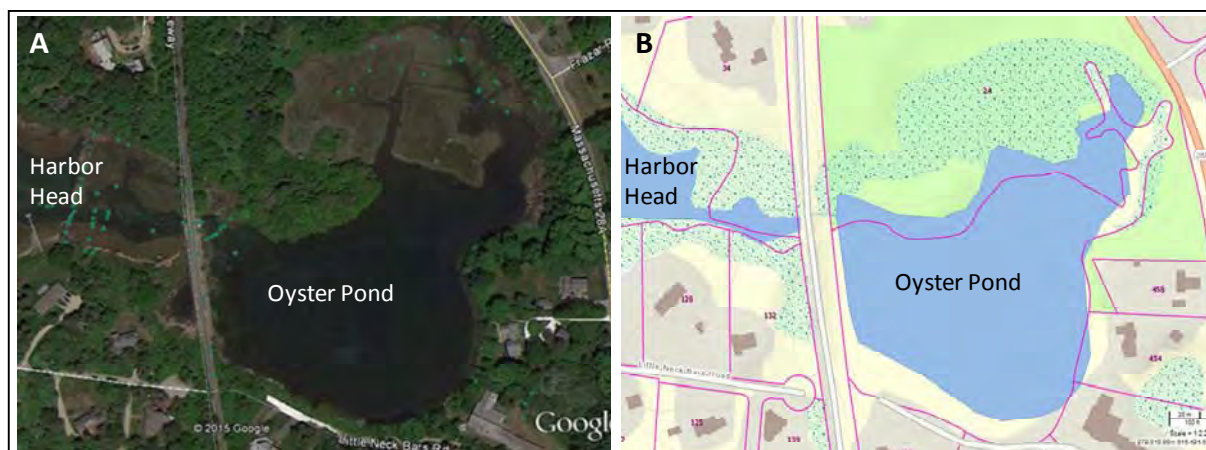
Figure 3.13. Location of Oyster Pond relative to Harbor Head: (A) turquoise dots are locations of RTK points collected in and near Oyster pond, (B) parcel map (Mass GIS) of abutting properties. A tidal creek connects Oyster Pond with Harbor Head.

3.3.1 Location. Oyster Pond is a subembayment of Harbor Head, which is in turn an extension of West Falmouth Harbor (Figure 3.13). Oyster Pond is separated from Harbor Head by a culvert under the Shining Sea Bike path, a paved, former railroad right-of-way. The corrugated culvert under the bike trail is 3.8 ft in diameter and is fairly new (Table 3.11, Figure 3.14). The outlet of the culvert and Harbor Head are connected by a 270-ft-long tidal creek, which is only 23 ft in width at the downstream end, at the location of an abandoned dike (Figure 3.15A). There is an 1.7-ft elevation gain along this channel to the culvert invert, then another 1.1-ft rise to a shoal on the upstream side of the culvert before reaching Oyster Pond proper (Figure 3.15B).

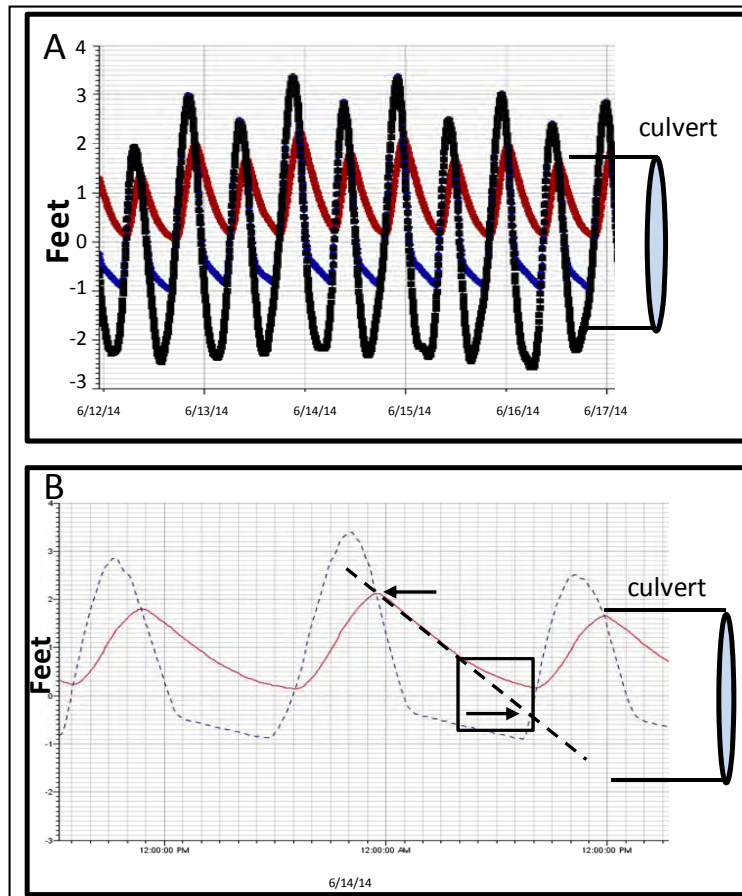
Figure 3.17. Water-level fluctuations for West Falmouth Harbor (black), Oyster Pond (red), and the tidal creek (blue), over (A) a 5-day period (during spring tides) and (B) over 24 hours. Dotted line shows slope of ebb flow rate

During ebb tides, when the elevation of water in the creek drops to the elevation of water in Oyster Pond (top arrow in Figure 3.17B), Oyster Pond begins to ebb as well. The rate of ebb in the pond is reduced relative to that of the creek due to the restrictive effects of the culvert. At about +0.7 ft, the rate of ebb slows further (top of box, Figure 3.17B), likely in response to bottom friction exerted by the shoal (elevation -0.7 ft), which is located about 43 ft upstream from the culvert (Figure 3.18). The rate of ebb is reduced further as the depth of water above the shoal become shallower. Without the shoal, but with the current culvert, water elevation in Oyster Pond could drop to about elevation -0.4 ft before the return of flood (lower arrow, Figure 3.17B). Thus, as a result of the shoal, about 0.6 ft is cut from the potential lower tidal prism of Oyster Pond, based on the slope of the dotted line. When the next flood tide of the creek reaches the water elevation of Oyster Pond 5-6 hours later, water again begins to flood into Oyster Pond, thus completing the cycle.

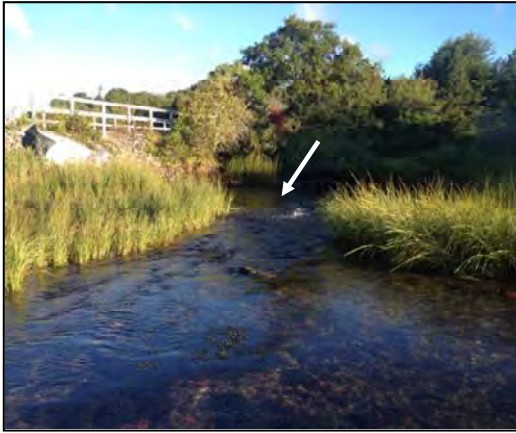
Figure 3.18. View of a shoal constituting a 1.1-ft elevation rise on the upstream side of the Oyster pond culvert. Oyster pond proper is in the foreground.

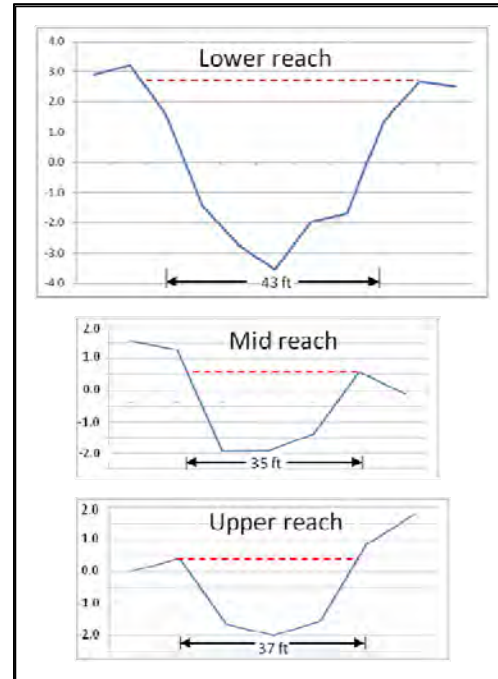
Figure 3.19. Cross-sections of the tidal creek emptying Oyster Pond, with channel widths indicated, are drawn to scale. Water-level logger was placed above the upper reach. Note elevation rise of thalweg from lower to upper part of the reach. Lower reach at the location of a former dike.

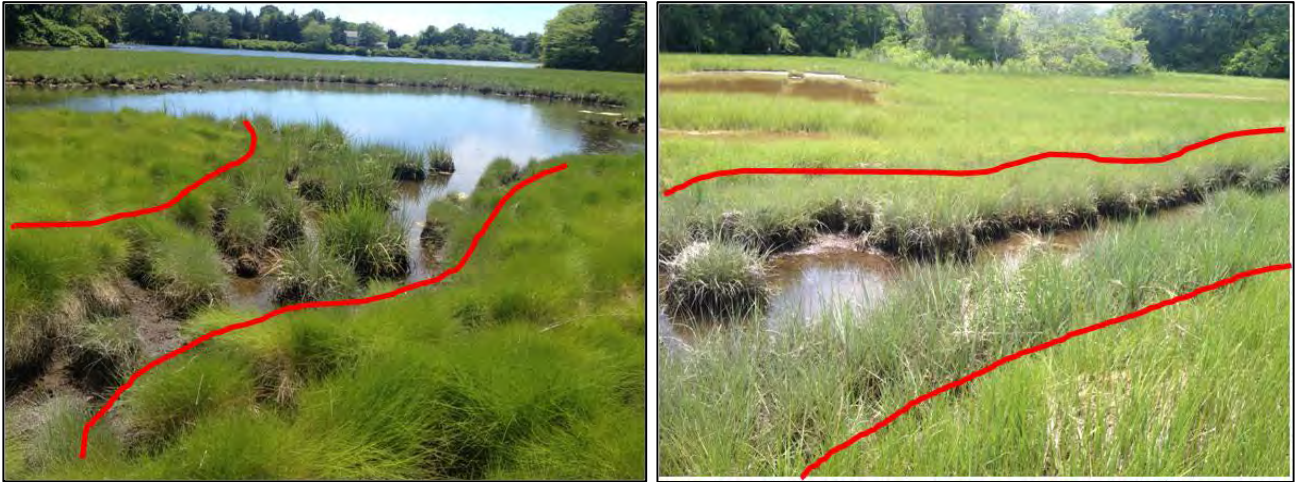
Figure 3.20. Salt marsh on Oyster Pond, showing break-up of marsh into hummocks. Note the turquoise color of marsh grass where marsh is breaking up.

Interestingly, marsh areas near creeks and historic mosquito ditches are breaking up. That is, chunks are sloughing into the creek and the edges are riddled with hollow areas interspersed with unstable hummocks. The color of the marsh grass within these slough zones are a dark bluish-green, in contrast to the more emerald-green color of the intact marsh areas (Figure 3.20). Because grasses with high nitrogen content also tend to be bluer in color (Schertz 1929), this suggests that the sloughing and marsh color could be indicators of nitrogen loading (eutrophication). In fact, the shoreline in front of 454 W. Falmouth Highway has a prolific growth of filamentous algae growing along the shoreline, an indicator of nitrogen-rich groundwater input.

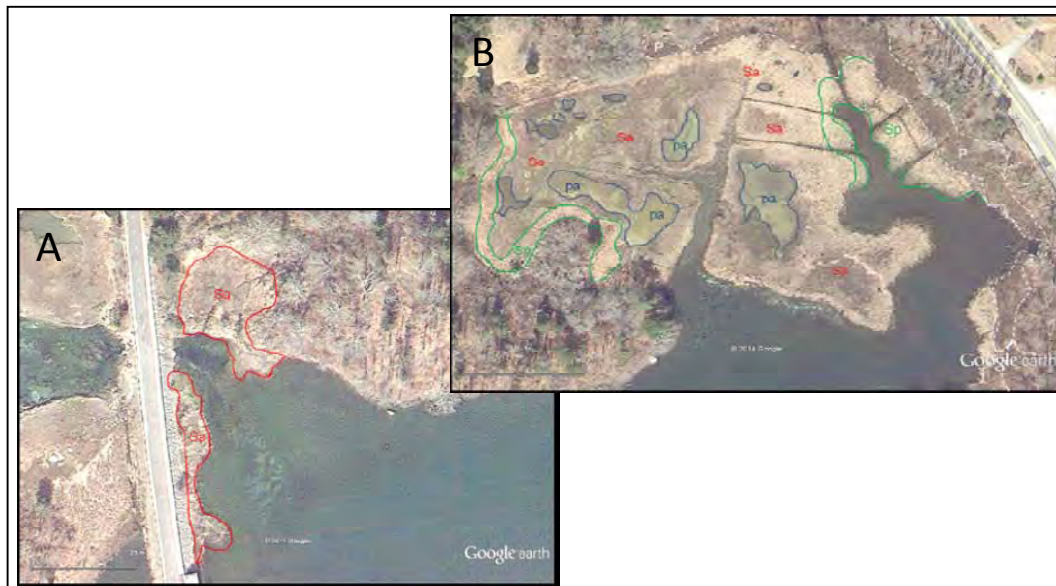
Figure 3.21. Spatial distribution of marsh cover-types in Oyster Pond. Abbreviations: P= *Phragmites*, Sa= *Spartina alterniflora*, Sp= *Spartina patens*, Pa= salt panne.

3.3.4 Spatial distribution of marsh cover-types. The study embayments support seven distinctive marsh cover types: *Spartina alterniflora* and *S. patens* marshes, *Phragmites* marsh, and salt panne. The estimated spatial distribution among these types was manually drawn in the field on aerial photos and transferred digitally to maps (Figure 3.21). This spatial distribution of cover types on these maps provides a baseline to compare changes in cover types after culvert enlargements have been completed, bearing in mind that it might take several years for vegetation changes to fully take place after tidal exchange is improved.
