ROAD SAFETY AUDIT

Route 28A from Lake Drive to Palmer Avenue

Falmouth and Bourne, MA

July 2025

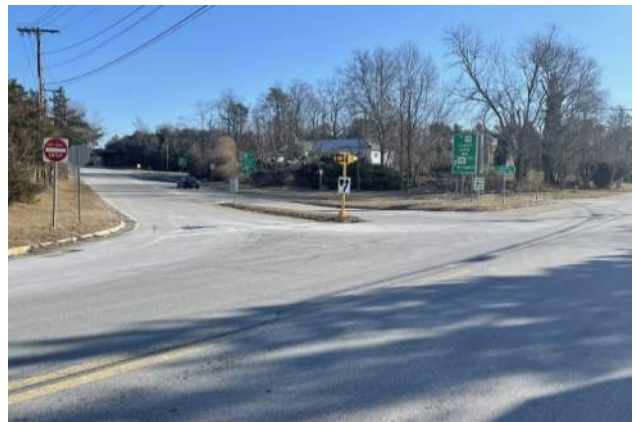
Signage visibility and retroreflectivity, especially during nighttime and low-light conditions, was noted as a safety issue by audit participants. Adequate roadway lighting was also recognized as essential for safety and visibility. Along the Route 28A corridor, 21% of crashes occurred under non-daylight conditions, highlighting the importance of illumination for nighttime safety.

Image 4: Thomas Landers Road/Route 28 intersection with no Roadway Lighting.

- Consider installing flashing LED STOP signs and advanced warning signage, where appropriate, to provide increased conspicuity of signage to drivers.
- At the Silver Beach Rotary, consider replacing existing black and white chevron R6-4 signs with new One-Way (R6-1 or R6-2) signs and reflectors to improve driver awareness, and consider installing additional roundabout pavement markings (including yield lines). Ensure that all new and existing signage and markings meet current standards, particularly for nighttime and low-light conditions.

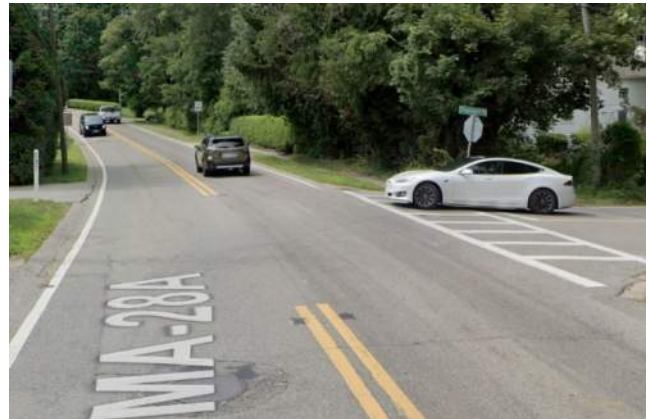
In particular, the segment near West Falmouth Square was identified as a concern. Participants noted that drivers entering this village area may not reduce their speed appropriately due to unclear transitions and lack of visual cues. The current location of the 35-mph speed limit signs was viewed as misaligned with the actual village context, contributing to inconsistent driver behavior and reduced compliance. Wide lanes, long uninterrupted segments, and a lack of gateway features may further contribute to driver overconfidence, reduced speed compliance and speed inconsistency.

Image 6: View from Route 28A Looking South at Chapoquoit Road with 40-mph sign on the far right (Google)

- Identify missing, damaged, or poorly placed speed limit signs and consider replacing or installing new speed limit signs where needed.
- Consider evaluating the potential use of gateway treatments at key transition points to alert drivers entering reduced speed zones.

- Ensure all speed limit signs are properly placed, visible, and retroreflective to maximize effectiveness, particularly for nighttime and low-light conditions.

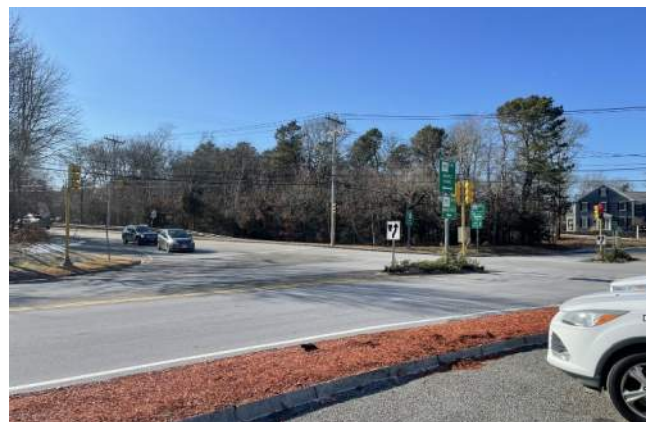
The intersection of Route 28A and Route 151 (Nathan Ellis Highway/County Road) was identified as a key area of concern due to multiple safety and operational issues. Crash data supports these concerns, with sixteen (16) reported crashes at this location, the highest of any intersection in the corridor, including a high percentage (50%) of angle crashes, which are often associated with turning conflicts. Existing signals at this intersection are post-mounted, making them harder to distinguish as drivers approach the intersection; Crashes #2, #3, #4, #8, #12, and #14 (Diagram A) can be partially attributed to signal visibility issues. In addition, each roadway approach widens approaching the intersection, creating a wide expanse of pavement within the intersection that encourages passing vehicles attempting to turn within the intersection (Crash #7 – Diagram A) and red light running (Crashes #4 and #12 – Diagram A).

Image 12: View from Silver Beach Pizza & Seafood to Route 151 / North Falmouth Highway intersection with poor layout

There are no dedicated left-turn lanes at this location, and local audit participants emphasized the difficulty of executing a southbound left turn onto Route 151 due to limited gaps in traffic and challenges judging
